Test pulse circuit for amplifier of charged particle detector in KOTO experiment

- KOTO experiment
- UCV for KOTO
- UCV Amplifier
- Test pulse circuit (TP)
- Design
- Operation check
- Conclusion

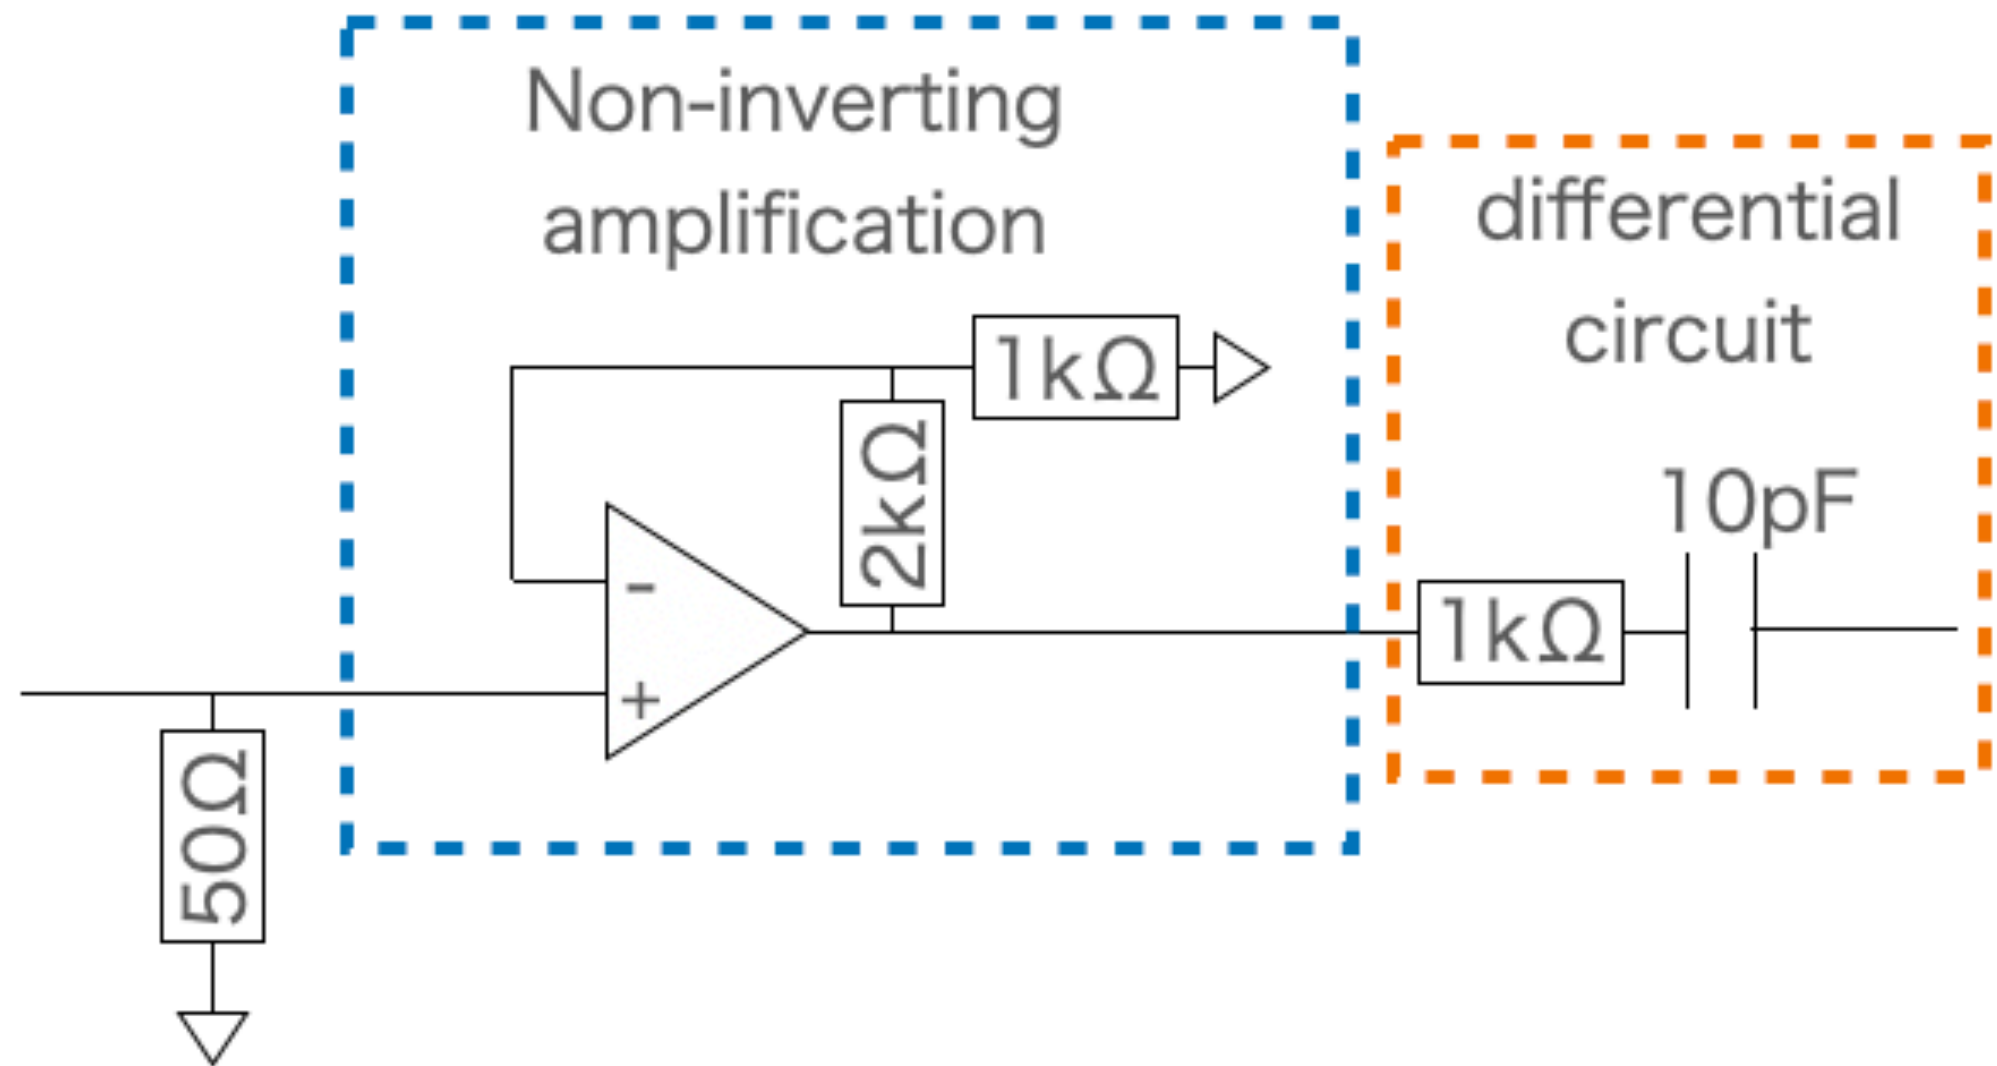
Design

- Used KiCad, and made the circuit board pattern

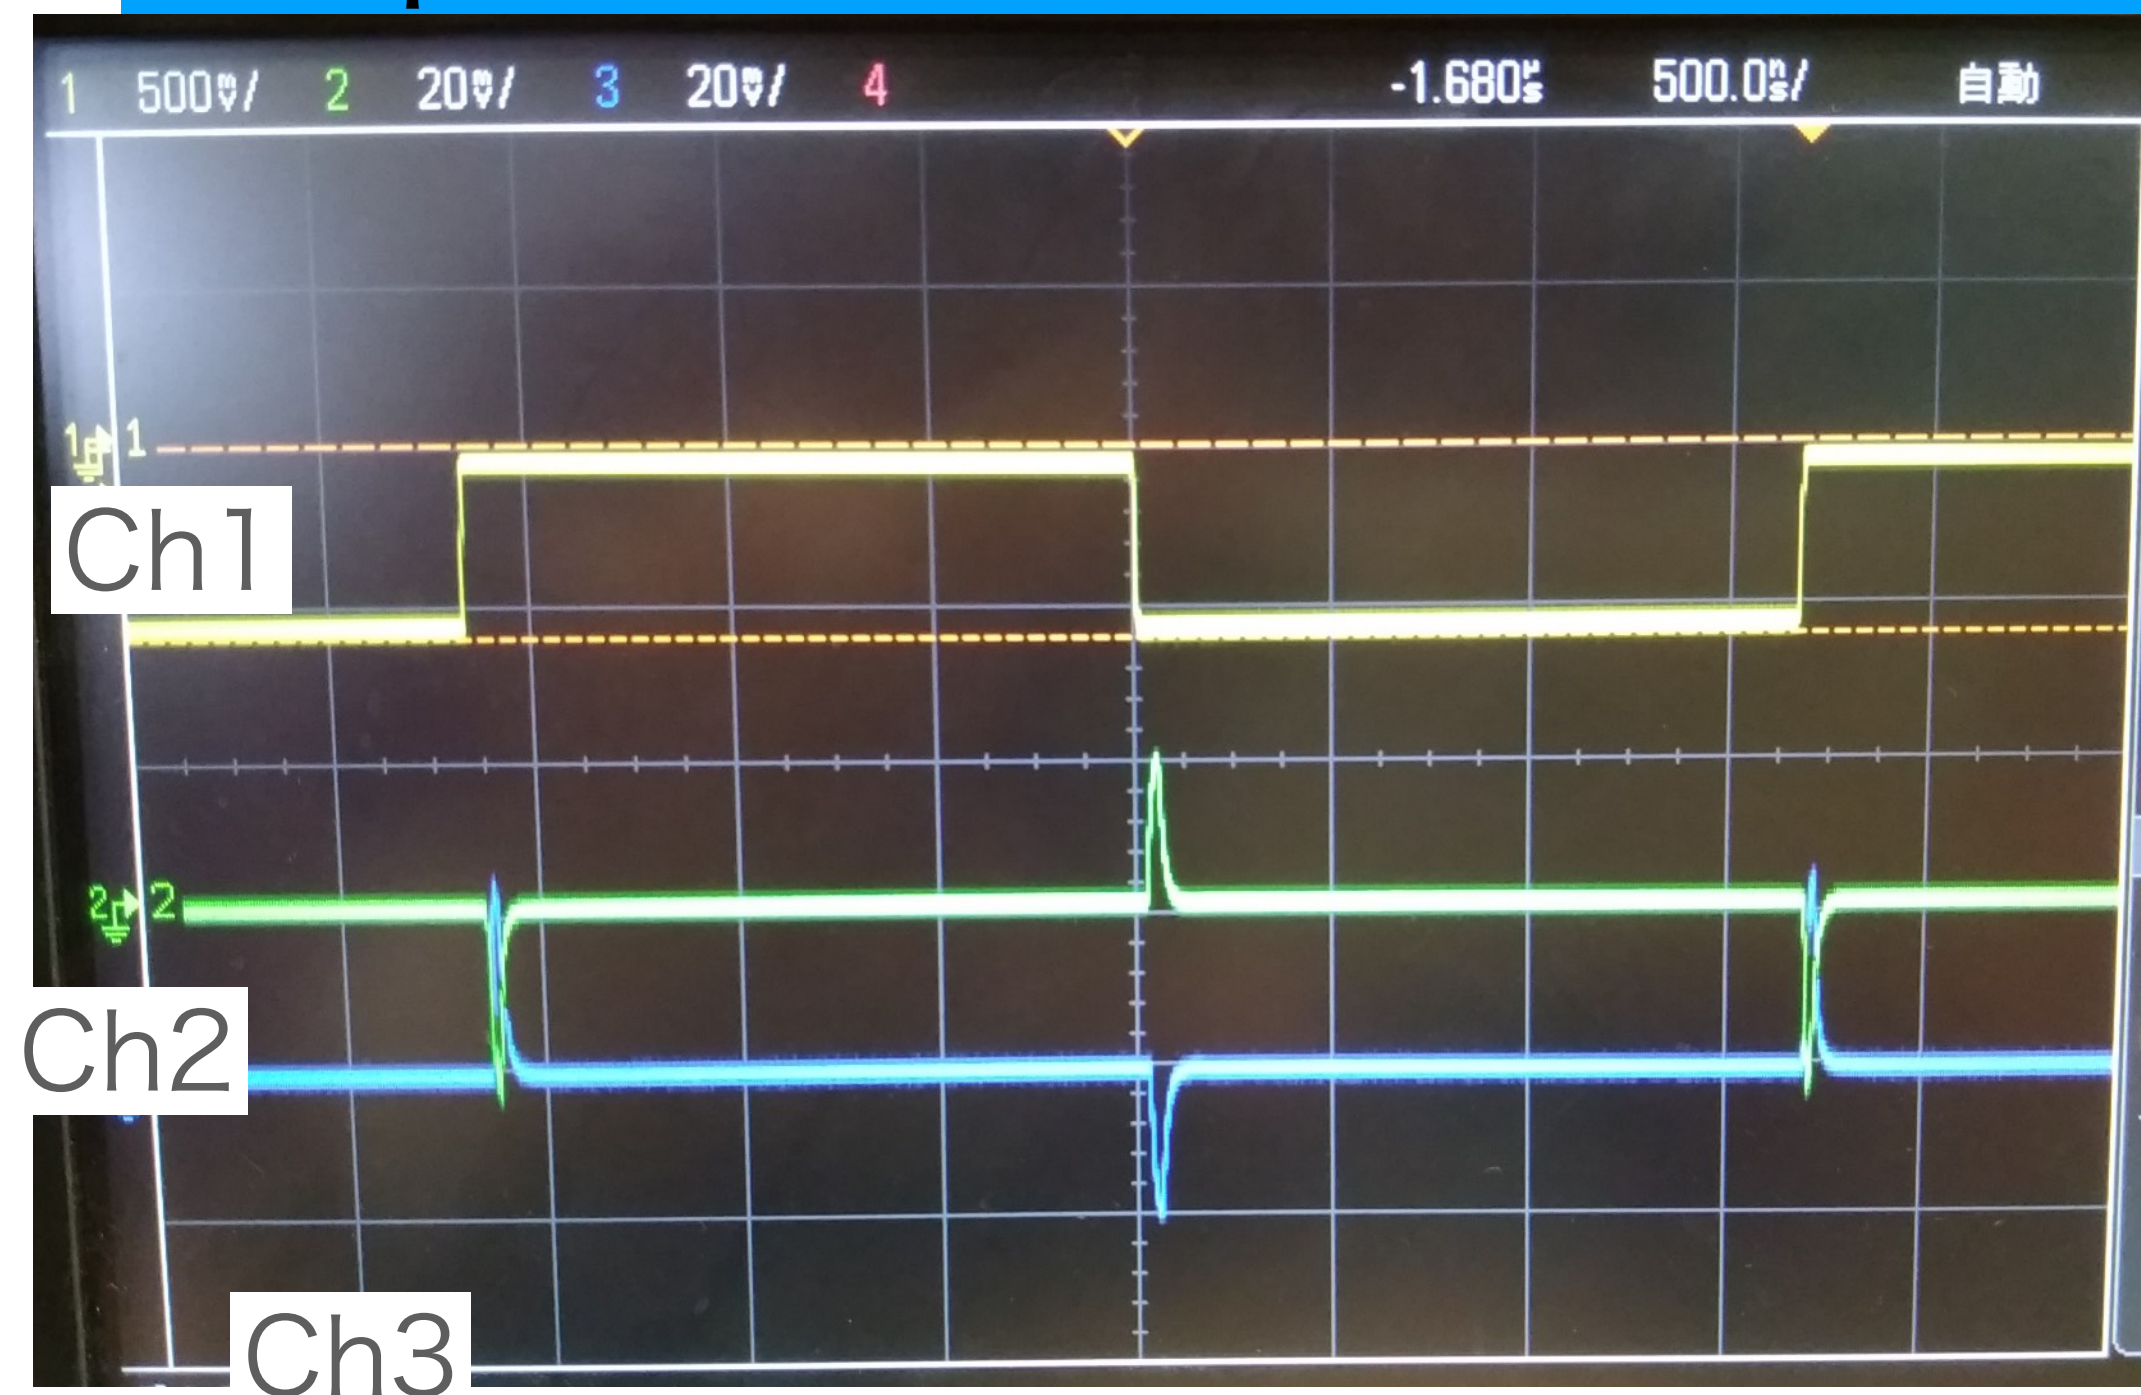
Output waveform

Calculated time constant : $1k\Omega \times 10pF = 10ns$

Measured time : 15 ns

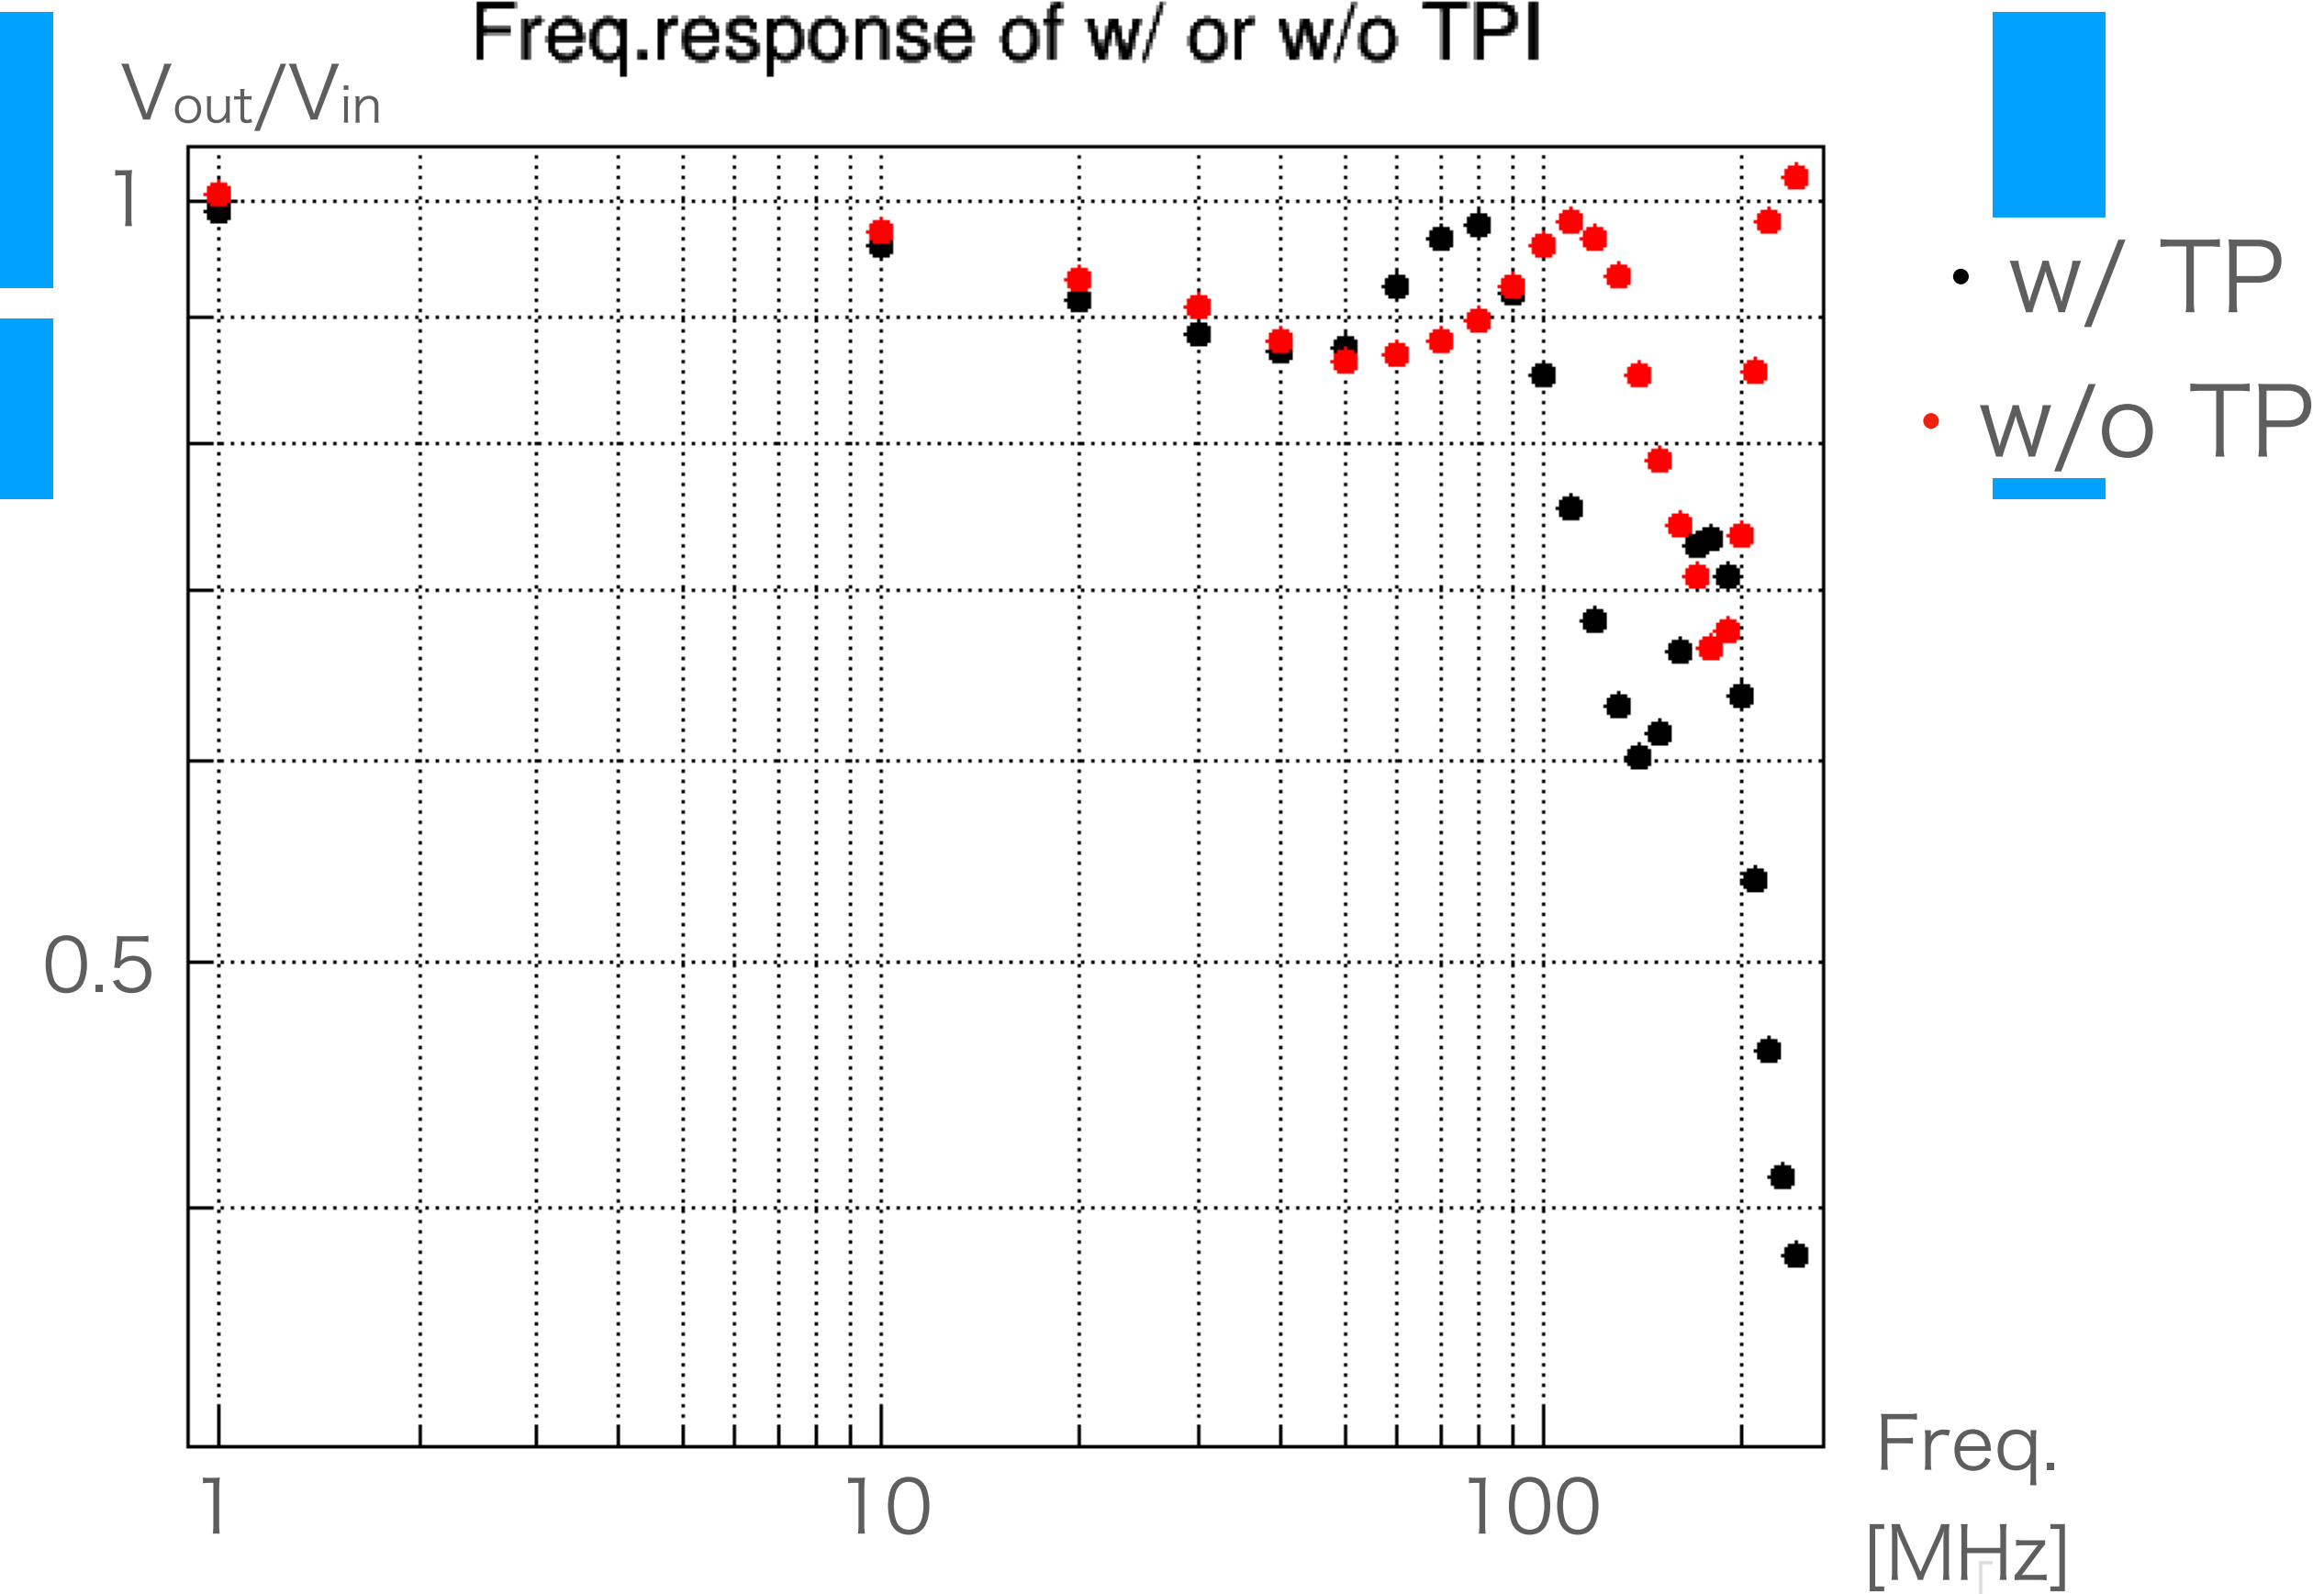
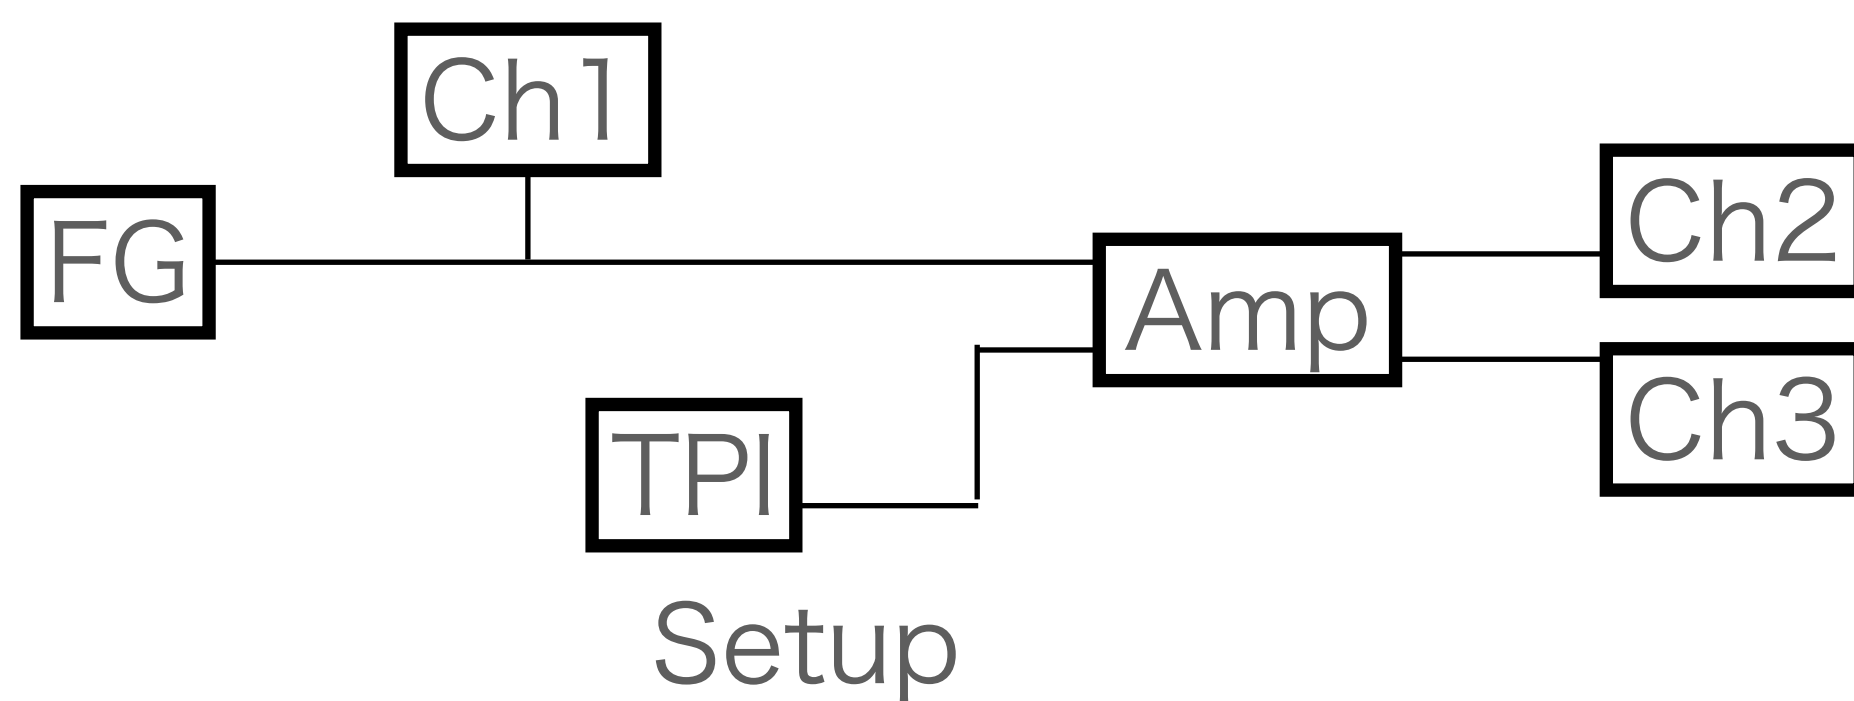
Effect on main signal

Used sine wave,
measured V_{pp} ,
calculated ratio

- Ratio was about 1 up to 10MHz
- Both plots are consistent up to 50 MHz

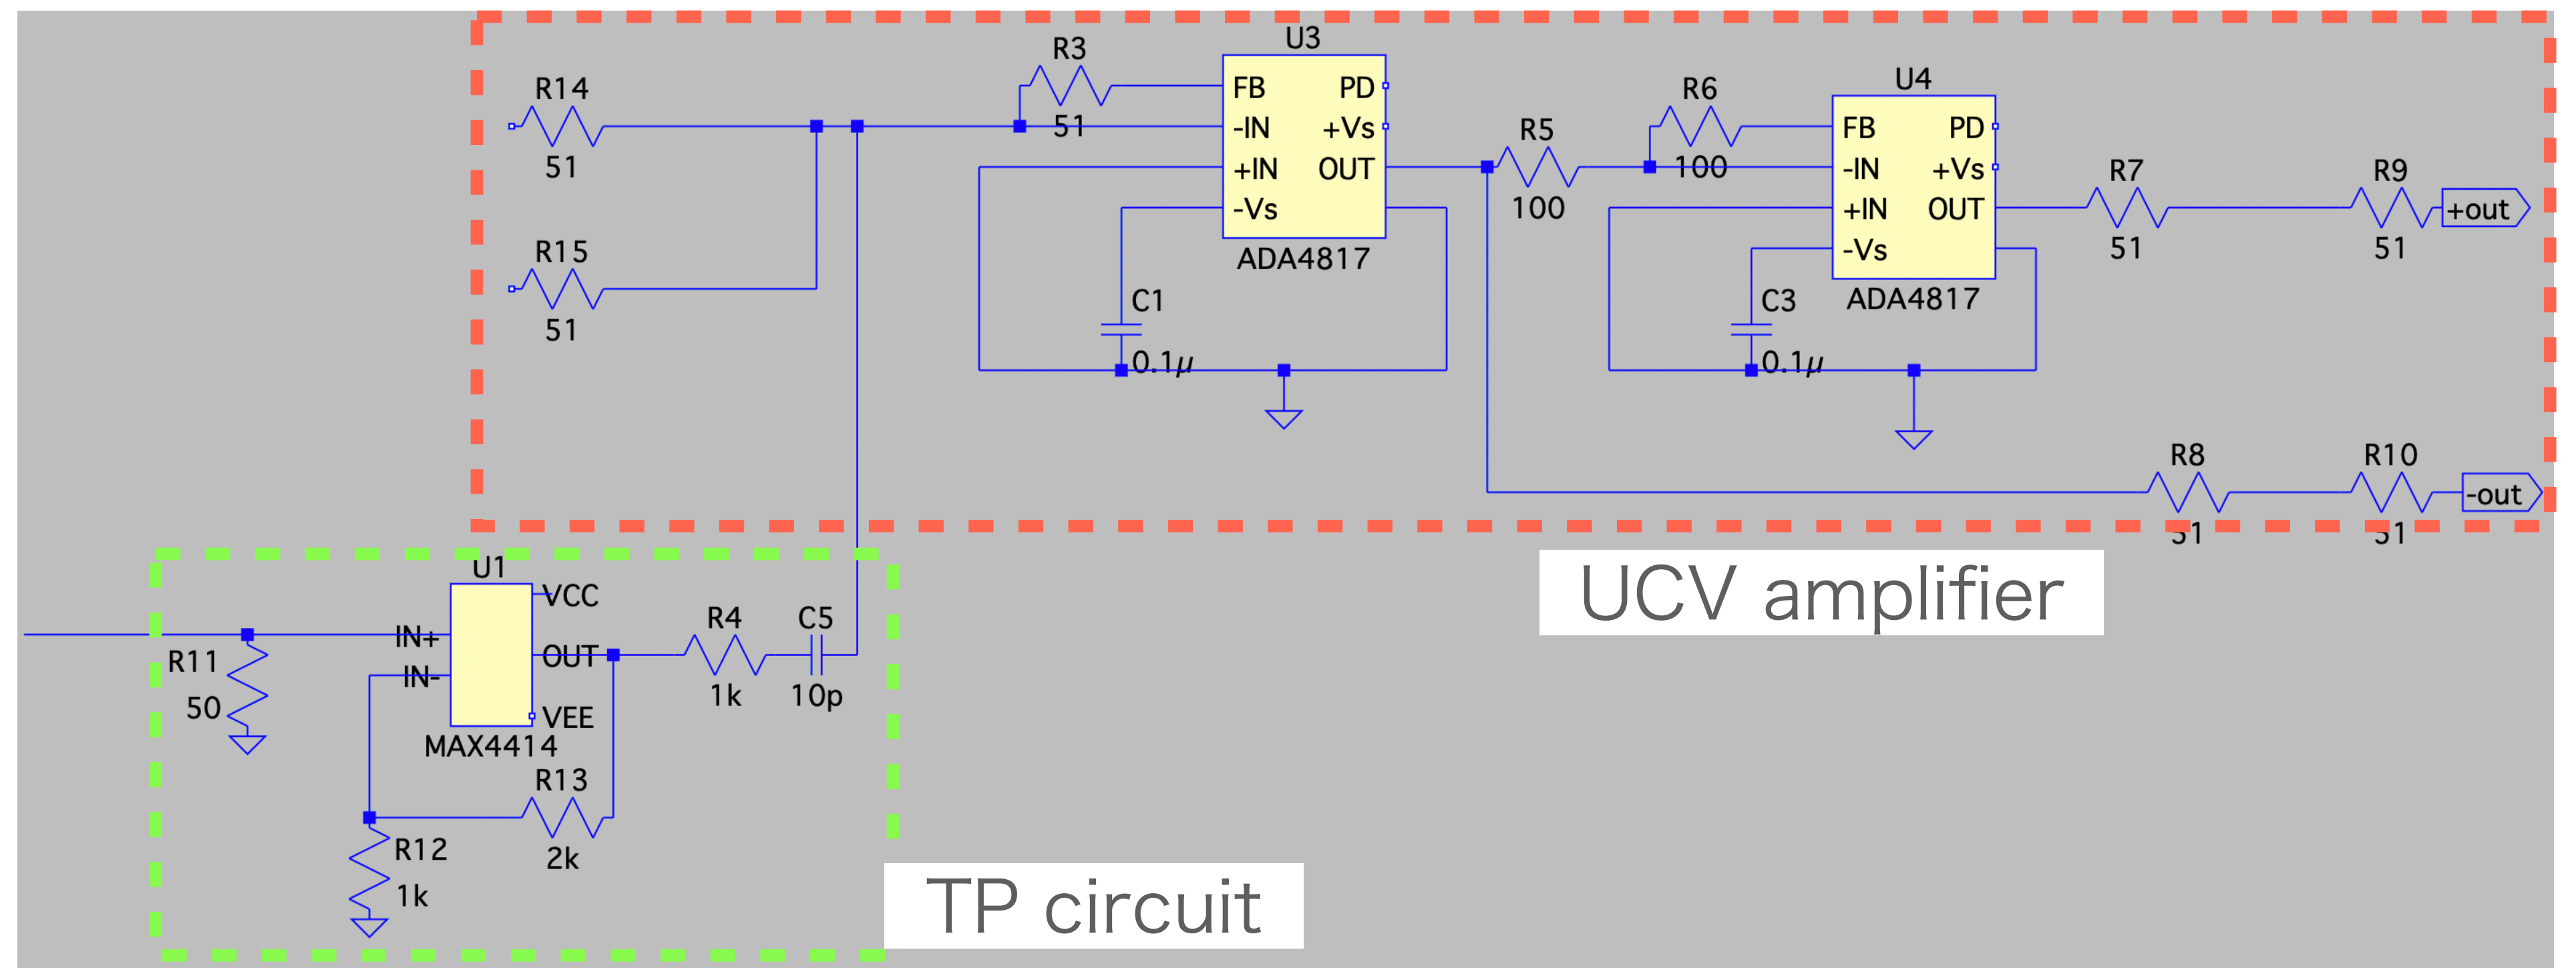
Design of a new board

- The new design adds TP circuit to the original board

TP circuit and UCV amplifier are on the same board

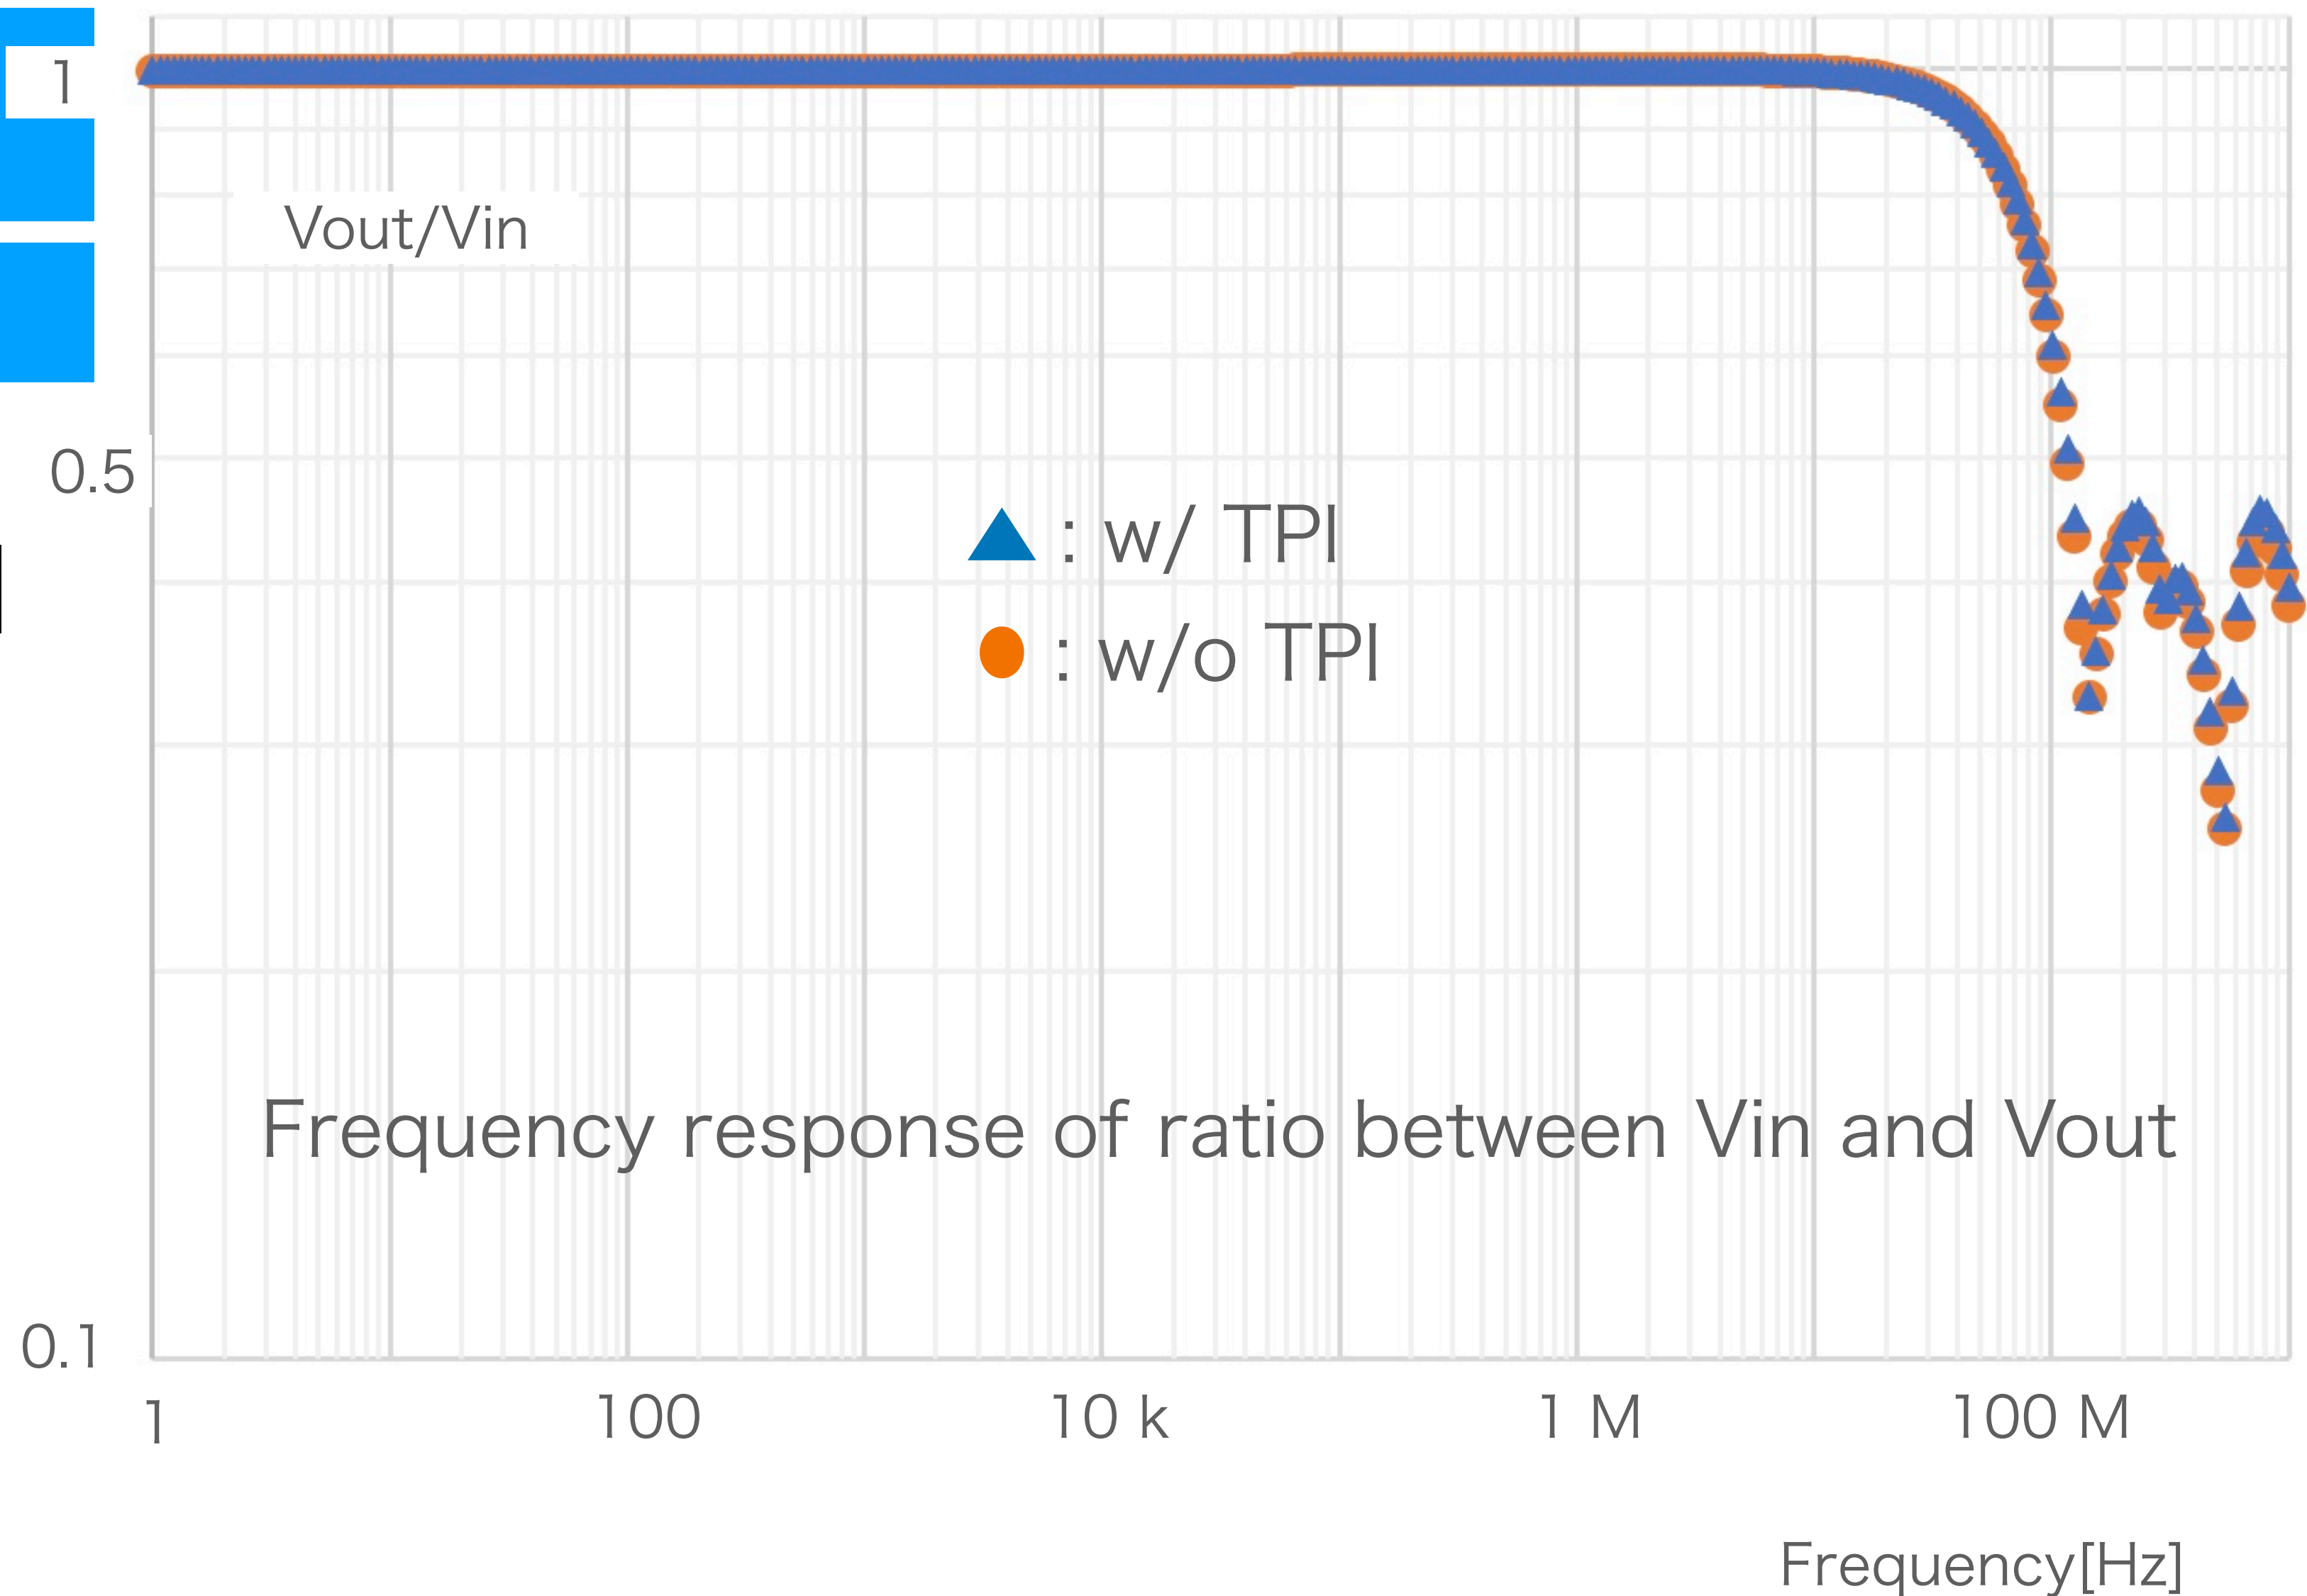
Result(check2)

- $V_{out} = |(+out)| + |(-out)|$
- Input-output ratio was about 1 up to 20 MHz

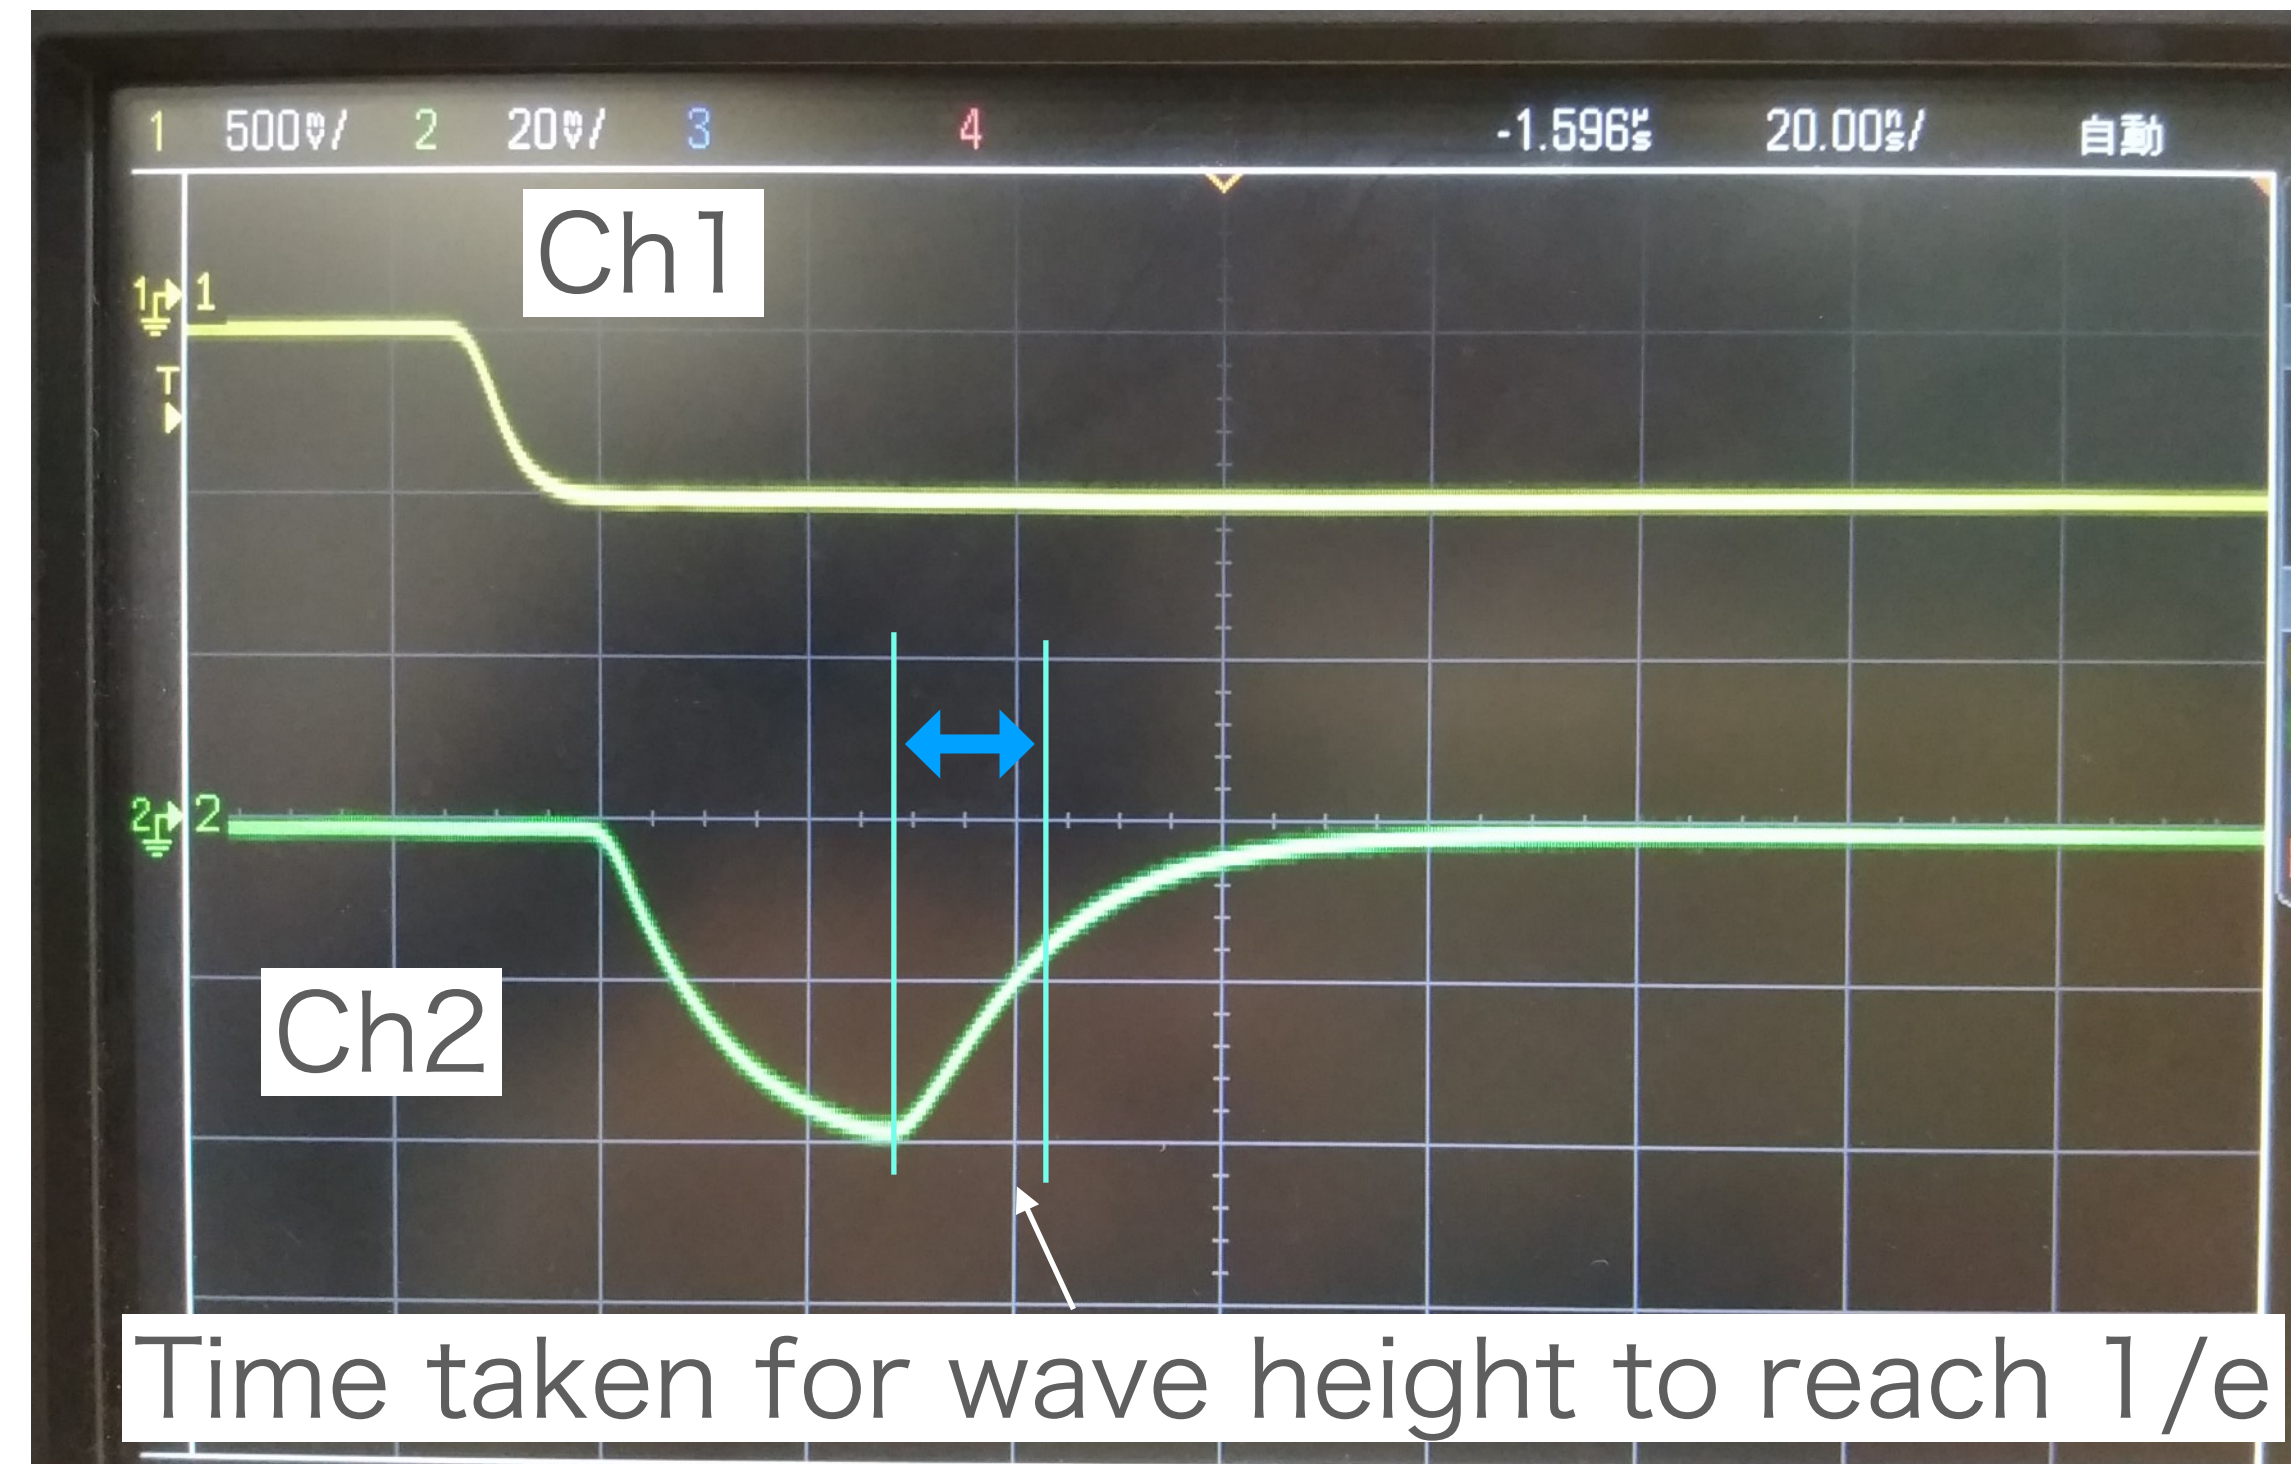
Output waveform

- Time constant(calculated) : 10 ns
- Measured time : 15 ns
